Portage Creek Sediment Remediation Project Kalamazoo, Michigan

Pre-Sediment Removal Structure Feature Assessment
Removal Areas SA5-Axtell, SA5-D and SA5-C

F&V Project Number: 809930
May, 2012

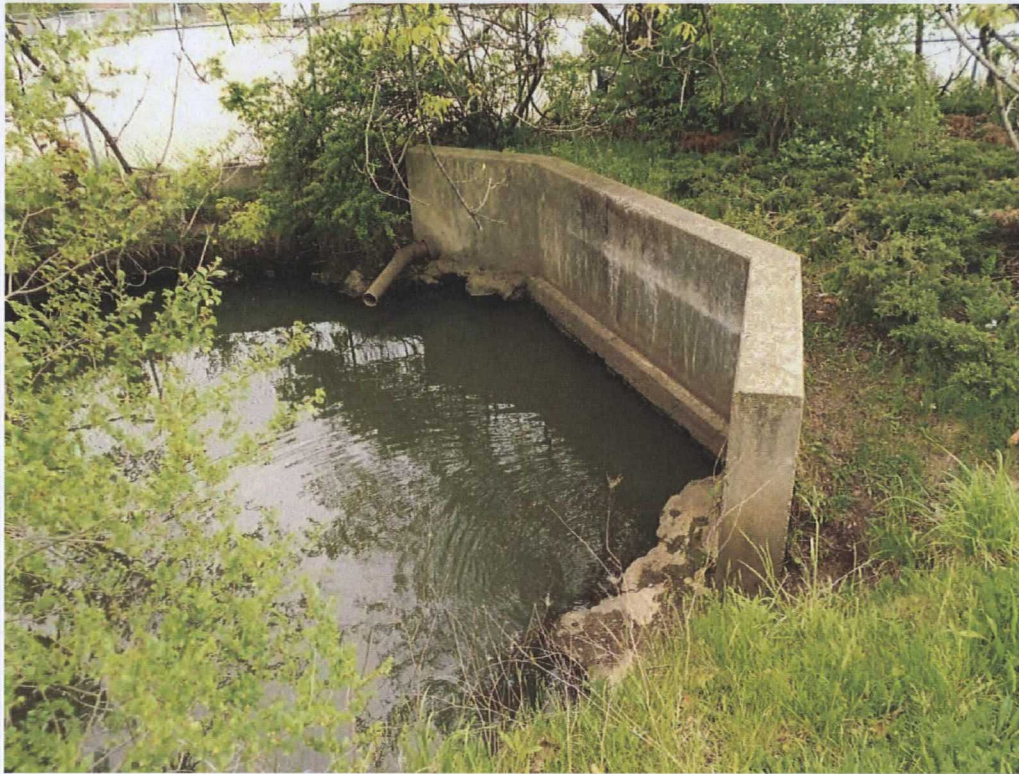
- Moderate slope erosion was noted behind the headwall and wingwalls.
- There is a large plunge pool/scour hole just downstream of the outlet.
- The structure includes a pipe penetration (possibly a storm water force main?) through the south wingwall. The pipe has moderate surface corrosion.
- Although the depth of the channel at the structure makes probing difficult, some slight undermining of the culverts is suspected due to the depth of scour.
- The concrete is in fair condition with no noticeable cracking.
- The concrete slope protection in front of the wingwalls is severely undermined from bank erosion.

Structure viewed from the north bank

- To avoid disturbance of the structure during sheet pile installation, it is recommended that the cofferdam be kept approximately 8-10' from the headwall (4-6' from the end of the wingwalls). If excavation is required closer to the structure, a sand bag cofferdam should be considered.

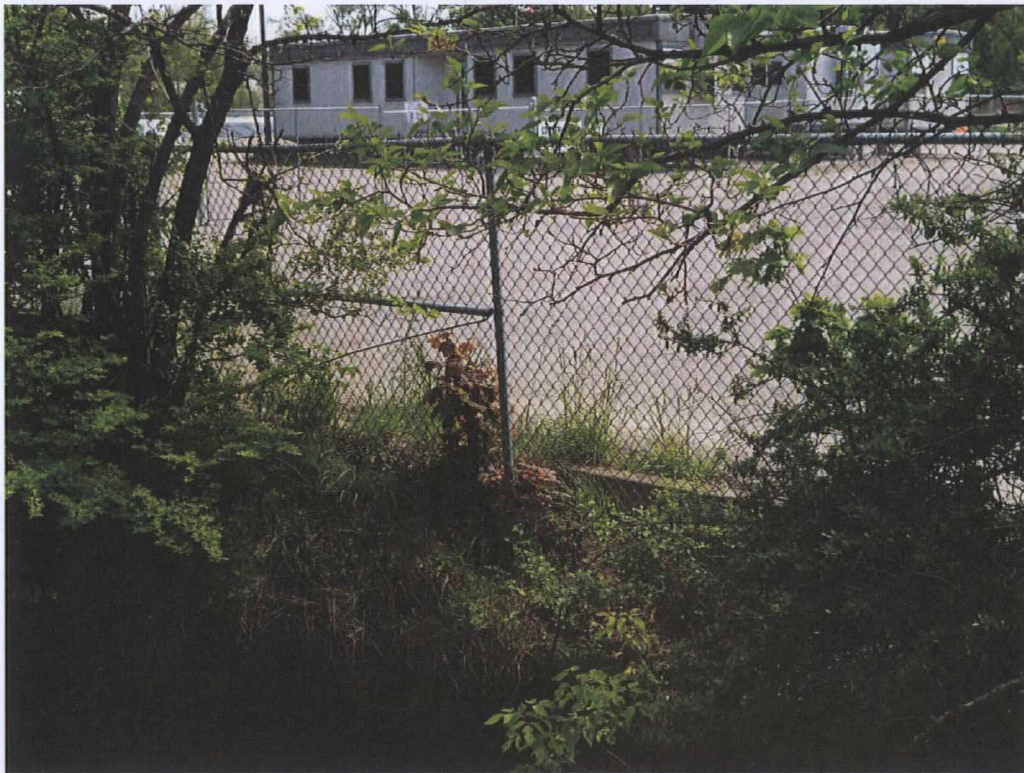
- A portion of the fence along the EQM Primary Support Area had been removed and replaced with construction fencing at the time of evaluation.
- An area of bank erosion has exposed a concrete base just downstream of the outlet structure.
- The fence is overgrown with vegetation in several areas.

Bank erosion just downstream of control structure

- Remove the fencing and replace in kind as required to facilitate sediment removal.

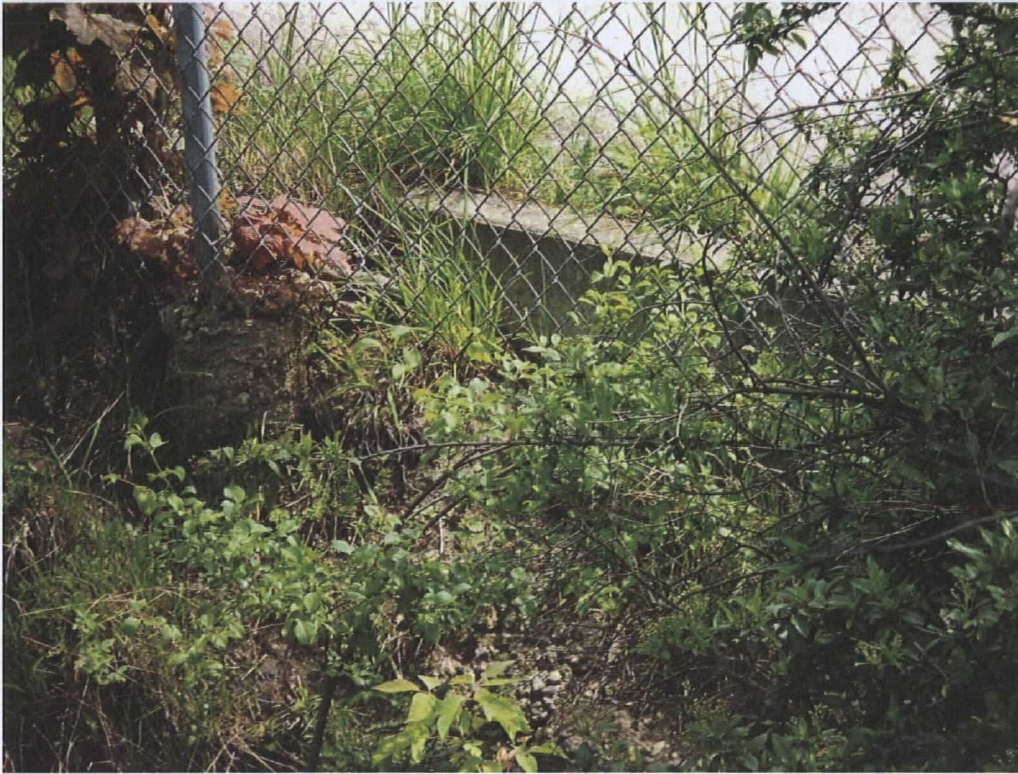
- The curb is generally in fair condition, however it has vegetation growth through several joints.
- An area of bank erosion has exposed the back of curb just downstream of the outlet structure, threatening to undermine the curb.

Bank erosion exposing back of curb and vegetation growth

- Protect the curb during sediment removal. Repair or replace undermined or broken sections of curb as required.
- Maintain approximately 2 feet of clearance from end of sheet pile cofferdam to curb.

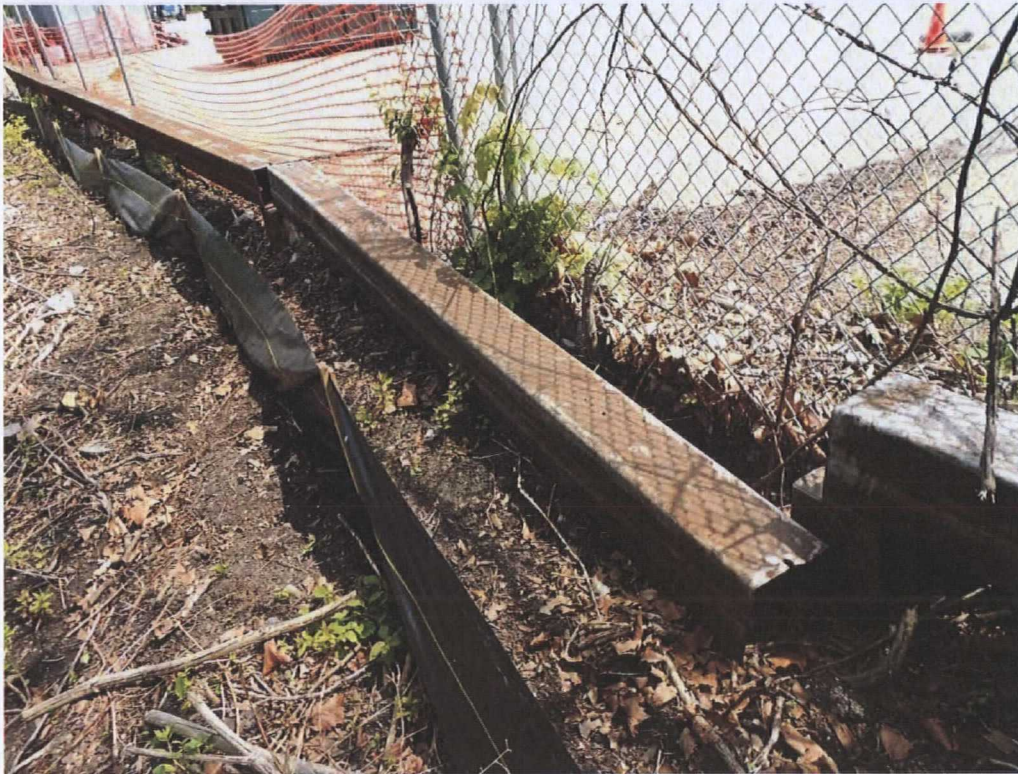
- The steel rail and posts have minor surface corrosion.
- Several posts have been exposed from bank erosion.
- Several rail sections have failed.

Failed section of rail and surface corrosion on rail

- Protect the rail during sediment removal or remove and replace in kind as required.
- Because the parcel is currently vacant, it may be possible to contact the City of Kalamazoo and remove the rail entirely.

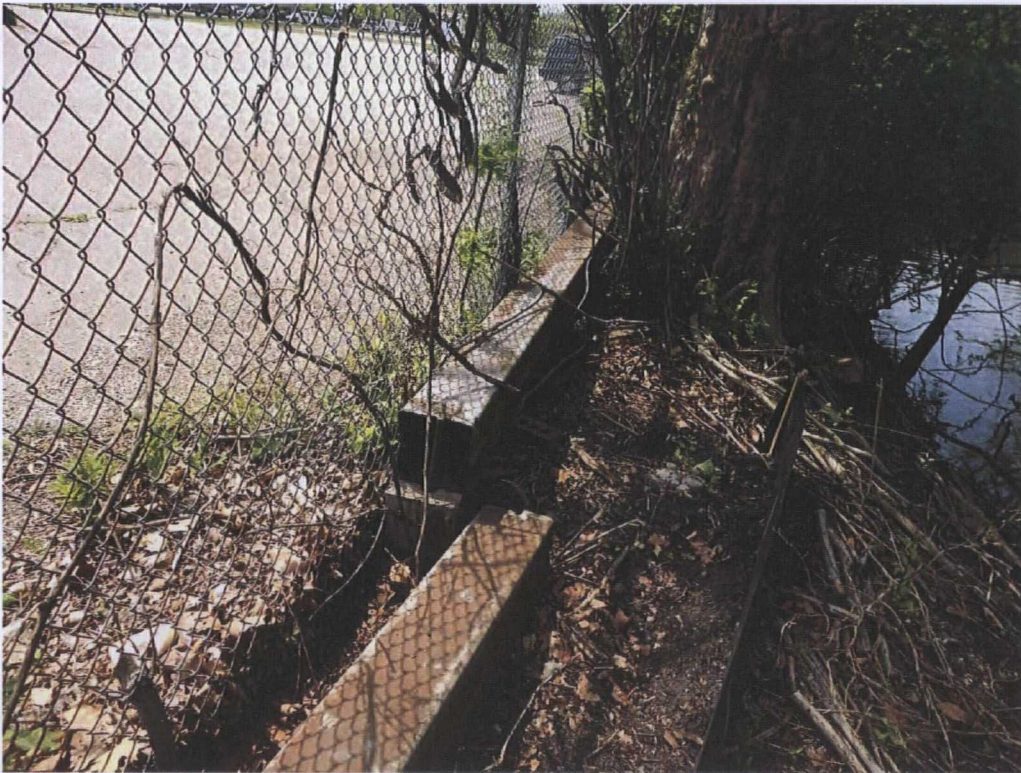
Failed section of rail and surface corrosion on rail

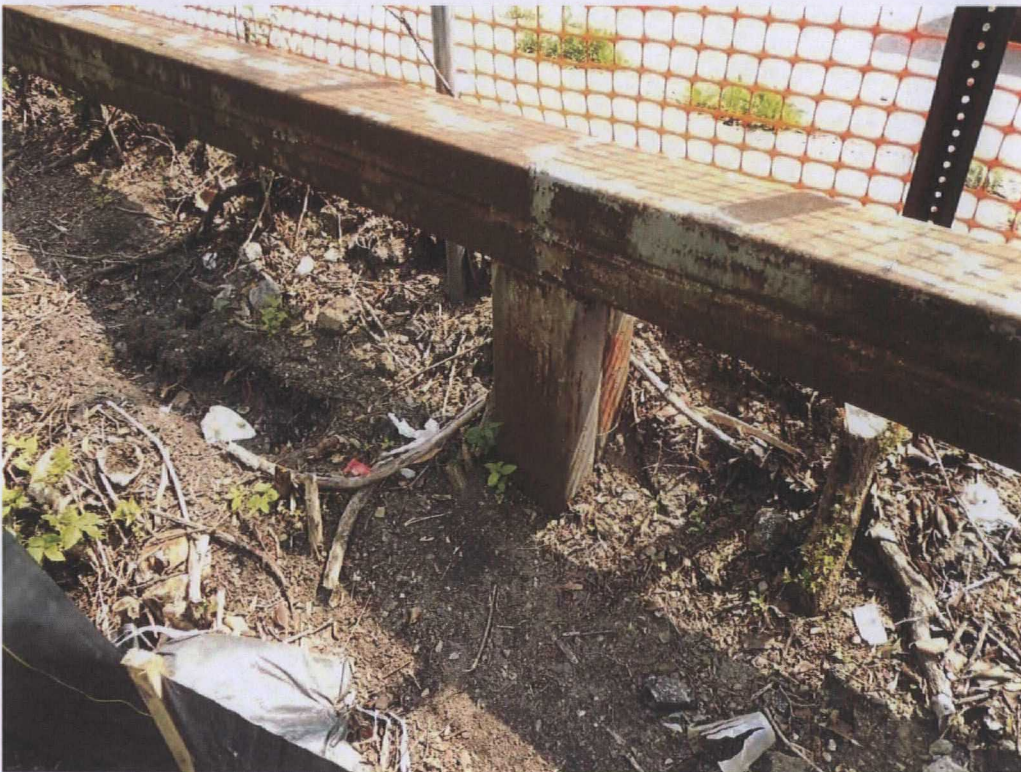
Post being exposed by bank erosion

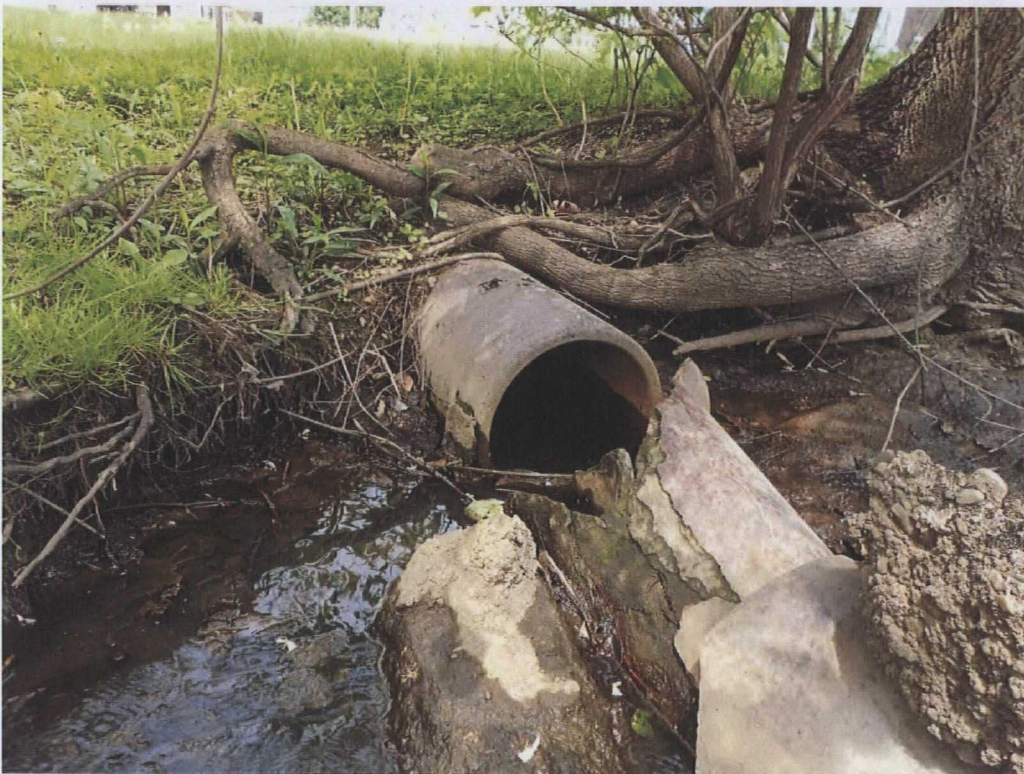
- The last 4 sections of pipe (~8') have failed from severe bank erosion. The bank has cut back ~12-18" on the fifth section.
- There is a sink hole and cracked bell on the 6th section, approximately 4' from the water's edge.

Fifth section exposed by bank erosion and failed fourth section

- Remove the 4 failed sections of pipe in the channel.
- Protect the remaining pipe with an isolation cofferdam to allow for dewatering. Provide approximately 2-3' of clearance between the cofferdam and end of pipe.

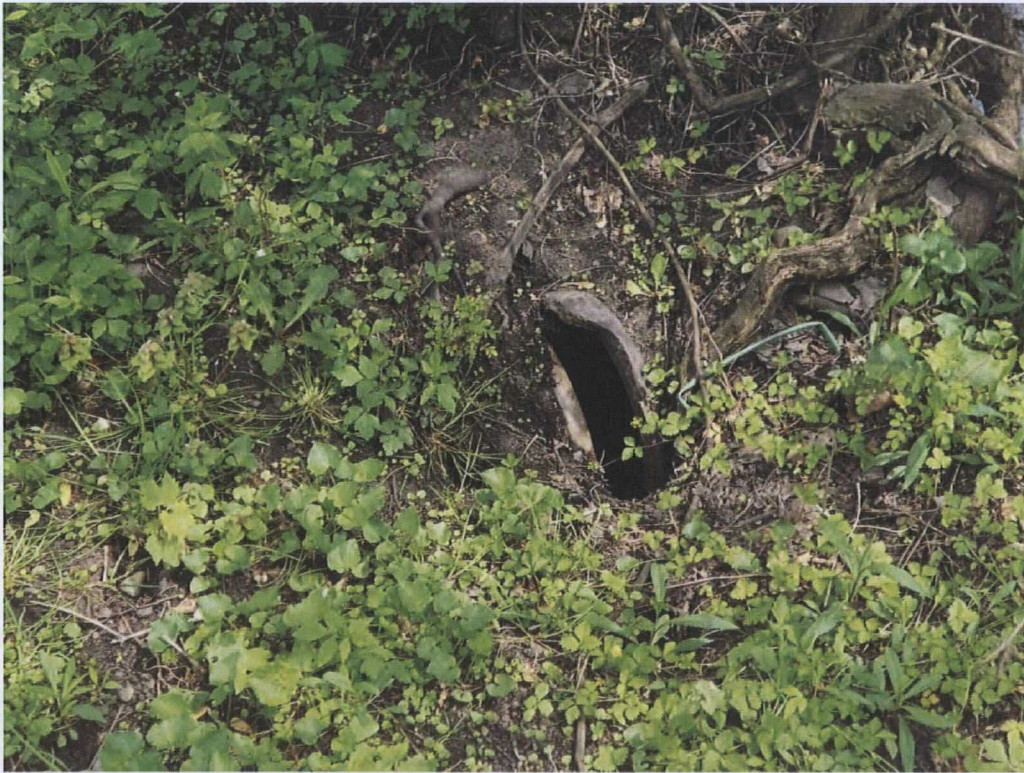
Sink hole at cracked bell section in the bank area

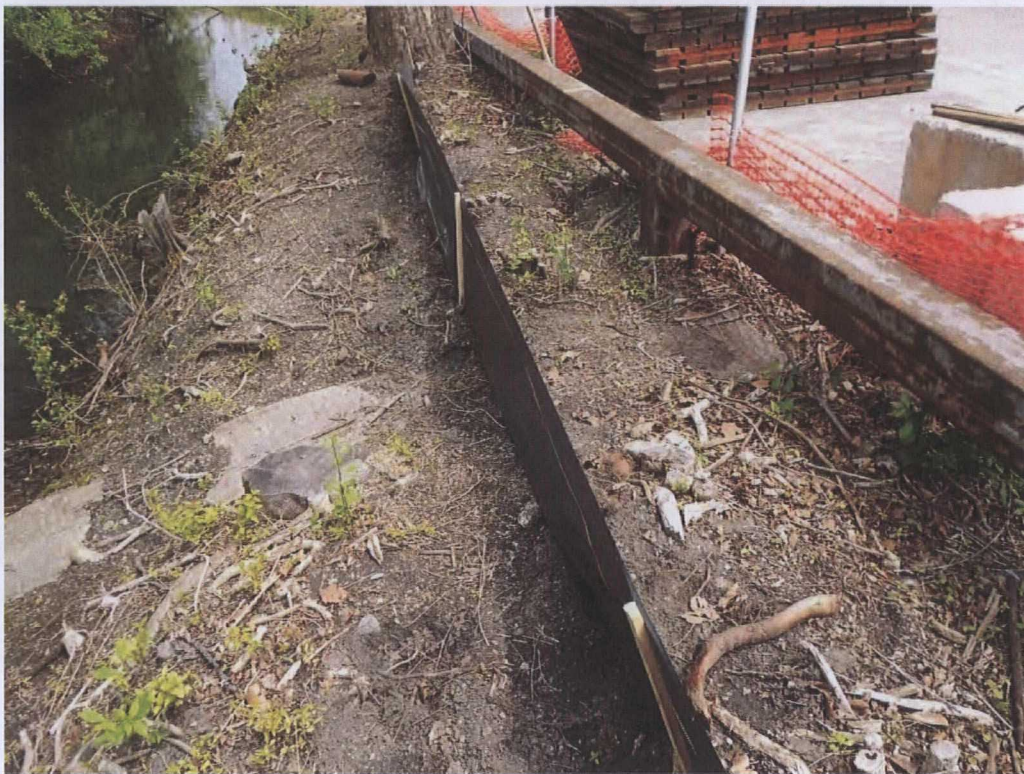
- The structure is in poor condition, nearly failed.
- The end of the spillway is severely undermined from bank erosion.
- The concrete has cracked allowing the end to slough down into the channel area leaving a ~2' gap in paving.

Concrete cracked and separated on left and covered with debris elsewhere

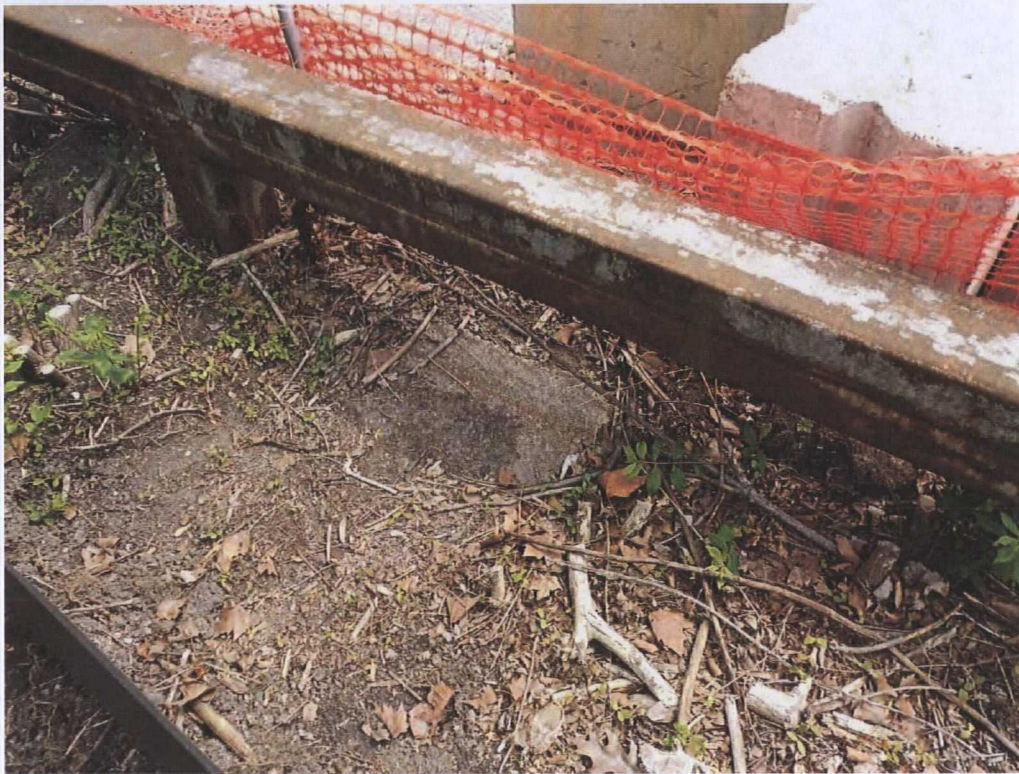
Separation between spillway and asphalt parking area

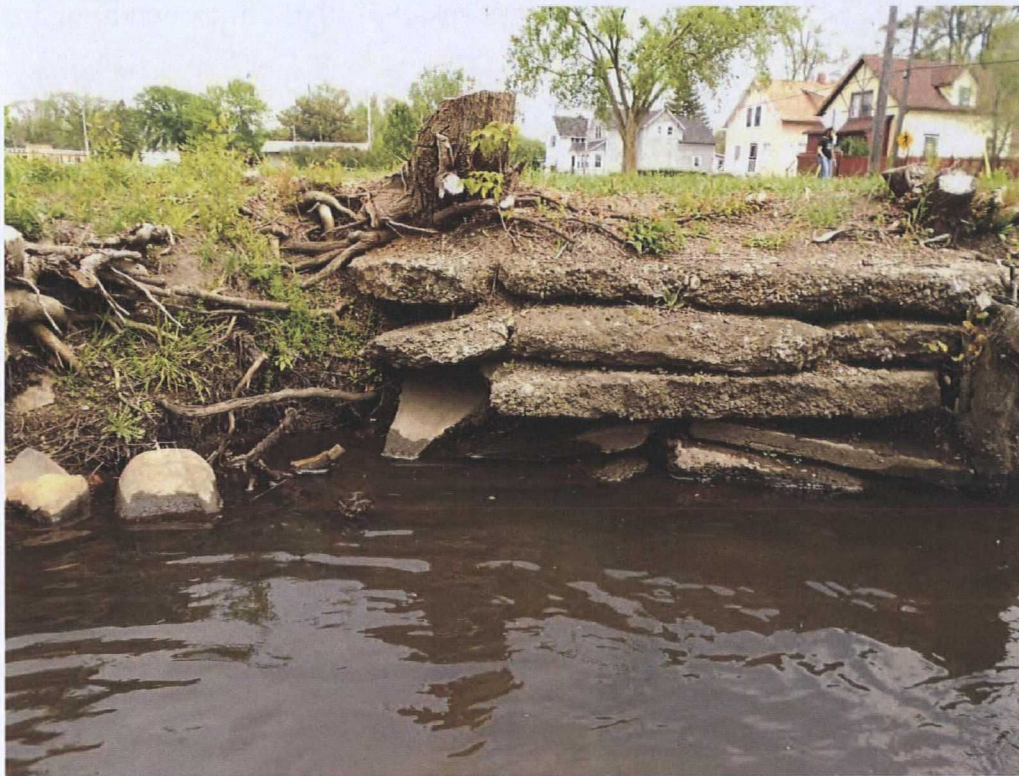
- Several of the slabs are failed or failing from cracking and undermining.
- The structure has severe tree growth and root intrusion, which is causing movement of the slabs.

Cracked, undermined and failing concrete slabs

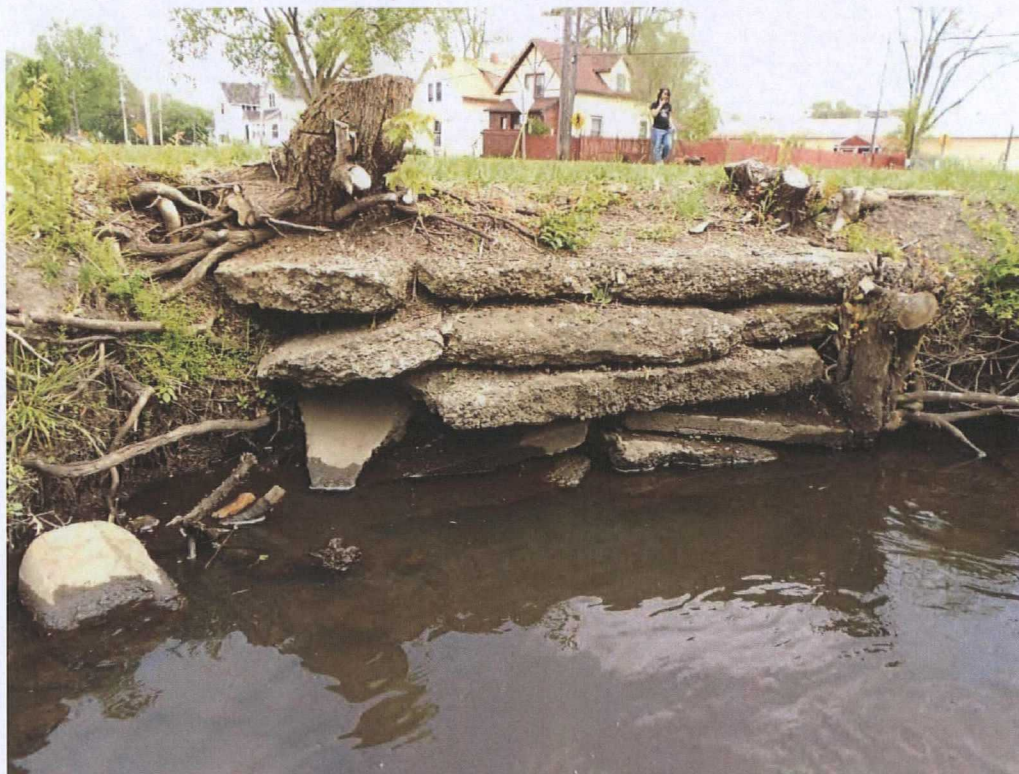
Cracked, undermined and failing concrete slabs

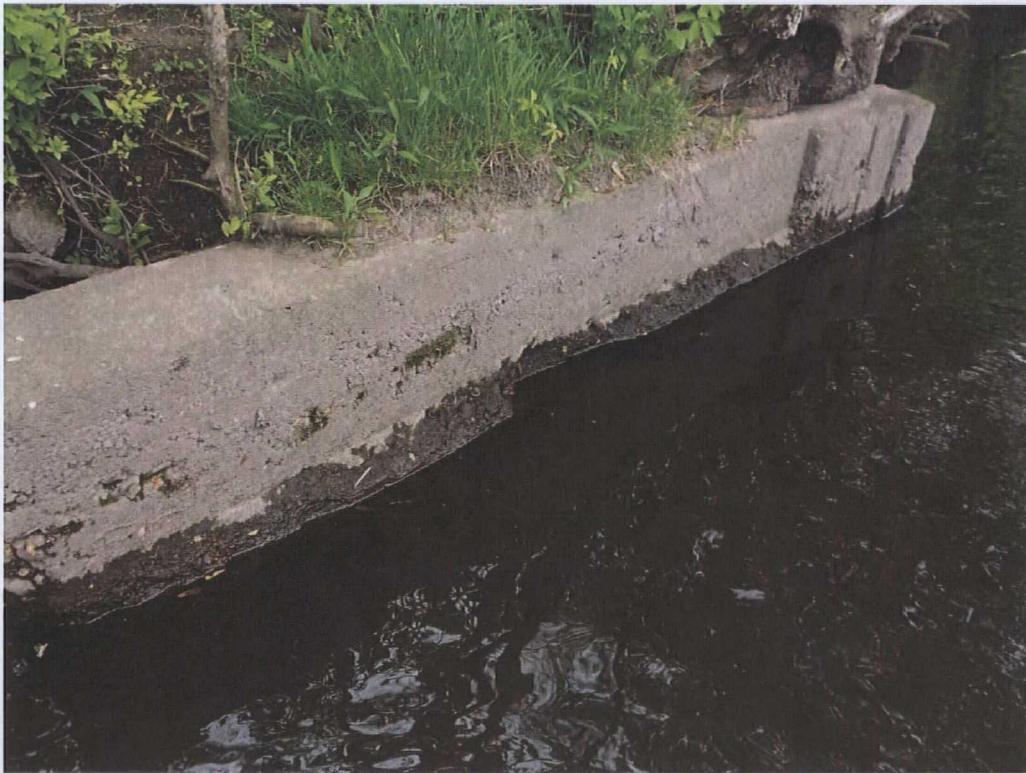
- The bank is severely eroded, approximately 4' behind the wall.
- The wall has severe tree and root growth behind it.
- The concrete surface has moderate abrasion and spalling along the waterline.
- Several sink holes and a partially exposed steel pipe were noted in the bank behind the structure.

Abrasion and spalling along the waterline

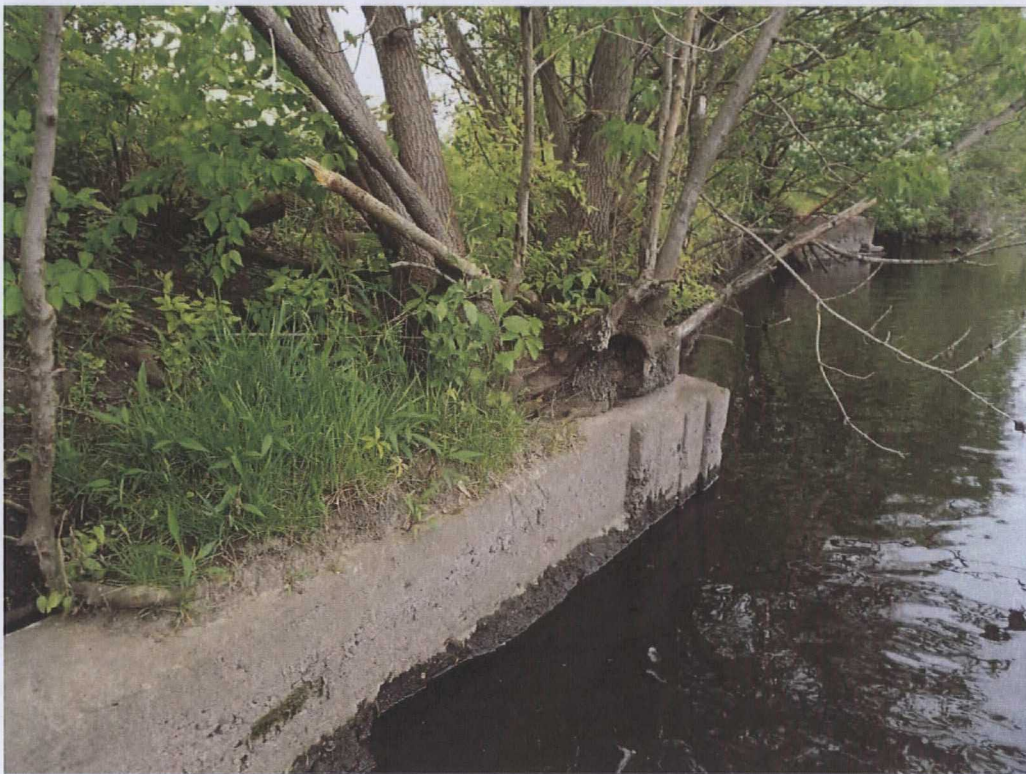
Severe tree and root growth behind the wall

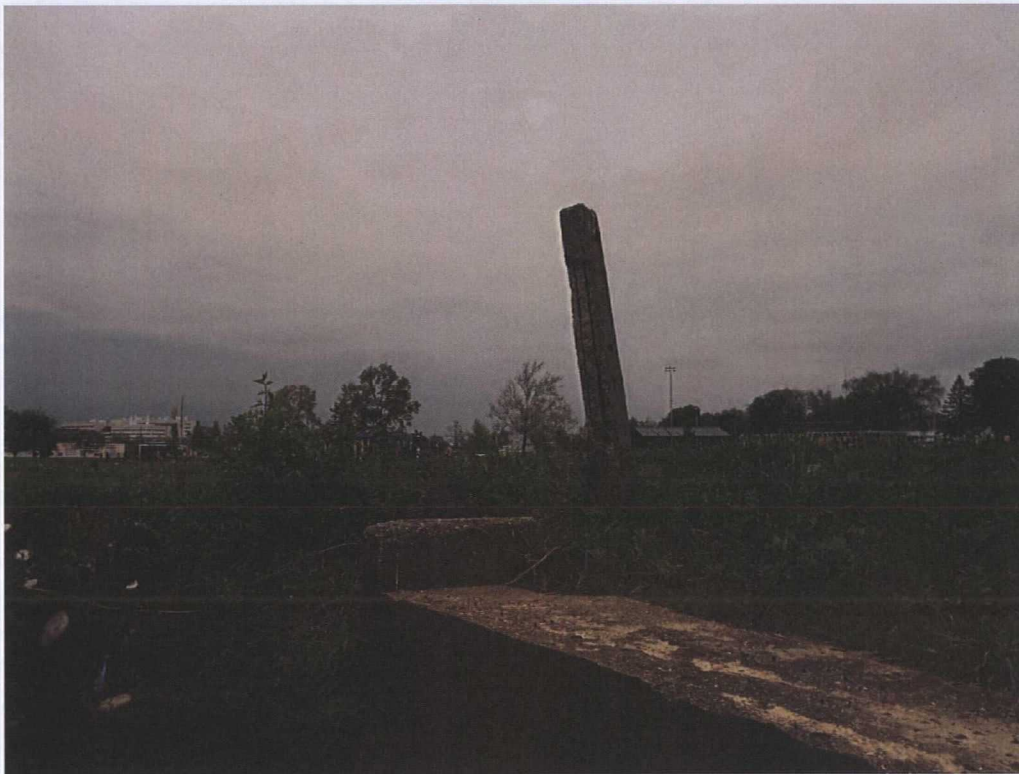
- Severe bank erosion was noted around the northeast, southeast and northwest and minor erosion in the southwest, however no undermining was detected.
- A severely spalled concrete post remains in the northeast and there is a failed concrete post on the southwest slope area.
- The concrete is in fair condition with shallow spalling and scaling as well as scattered cracking noted.

Severely spalled concrete post in the northeast

- Because the structure has been abandoned, it can likely be removed. However, it is recommended that the City of Kalamazoo be consulted to verify as it may be feasible to salvage the abutments for a future crossing at this location.

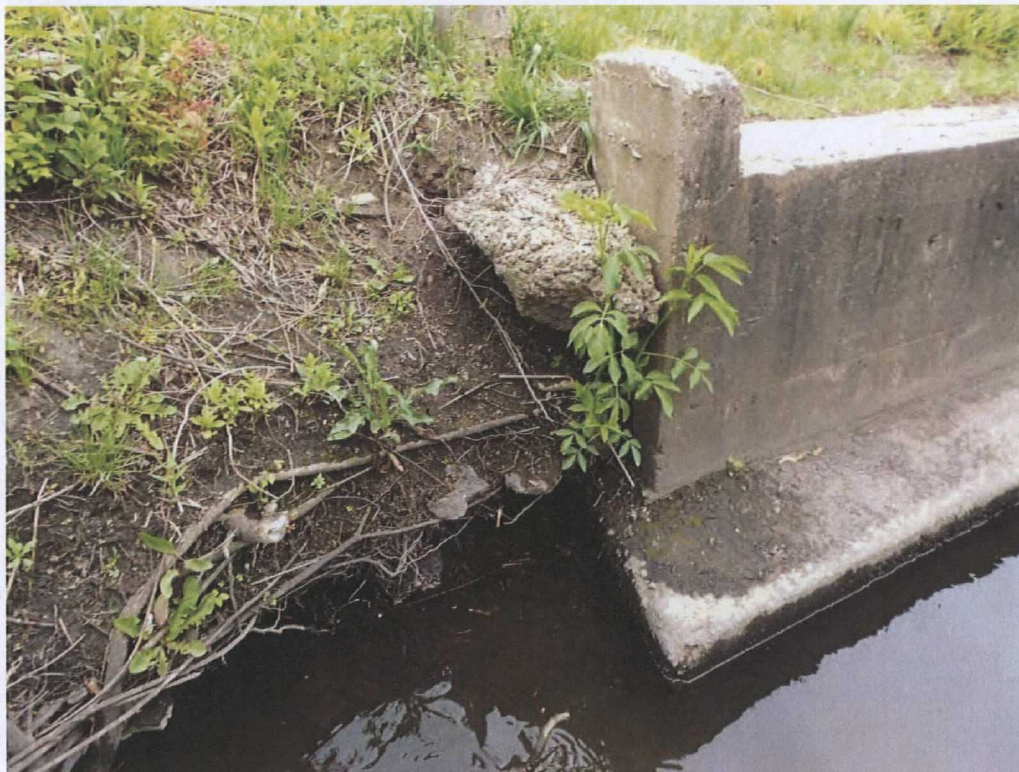
Severe bank erosion and failed protection in the northeast

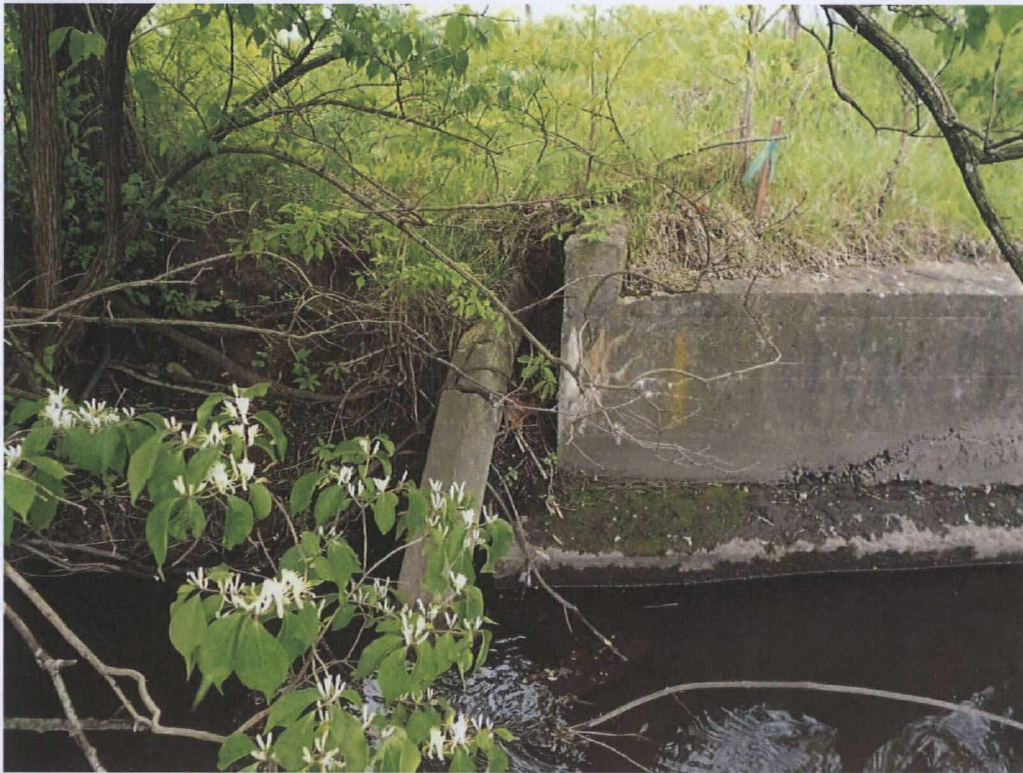
Failed concrete post in the southwest

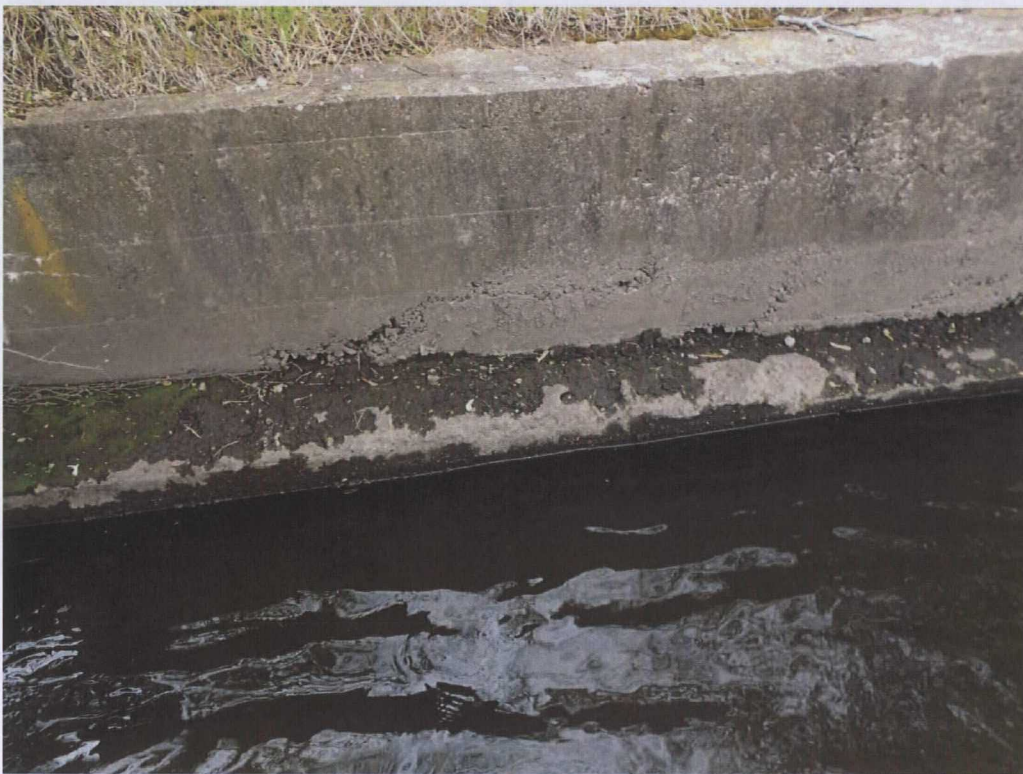
Minor honeycombing and abrasion of concrete surface just above the footing

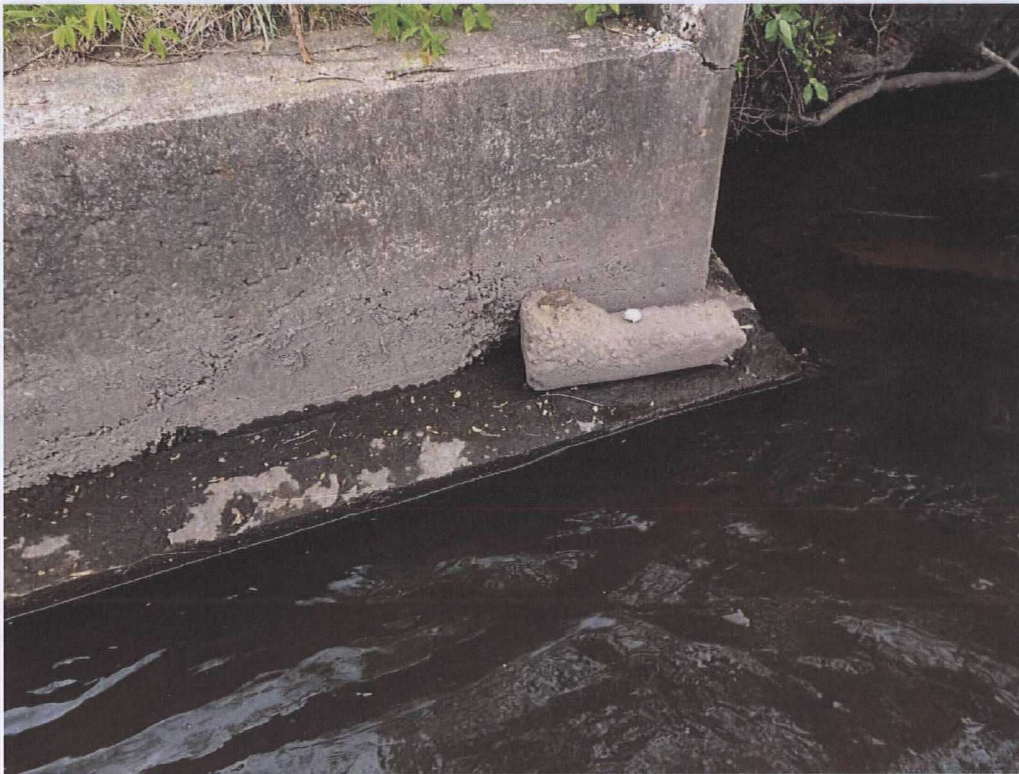
Failed concrete on footing in the northwest

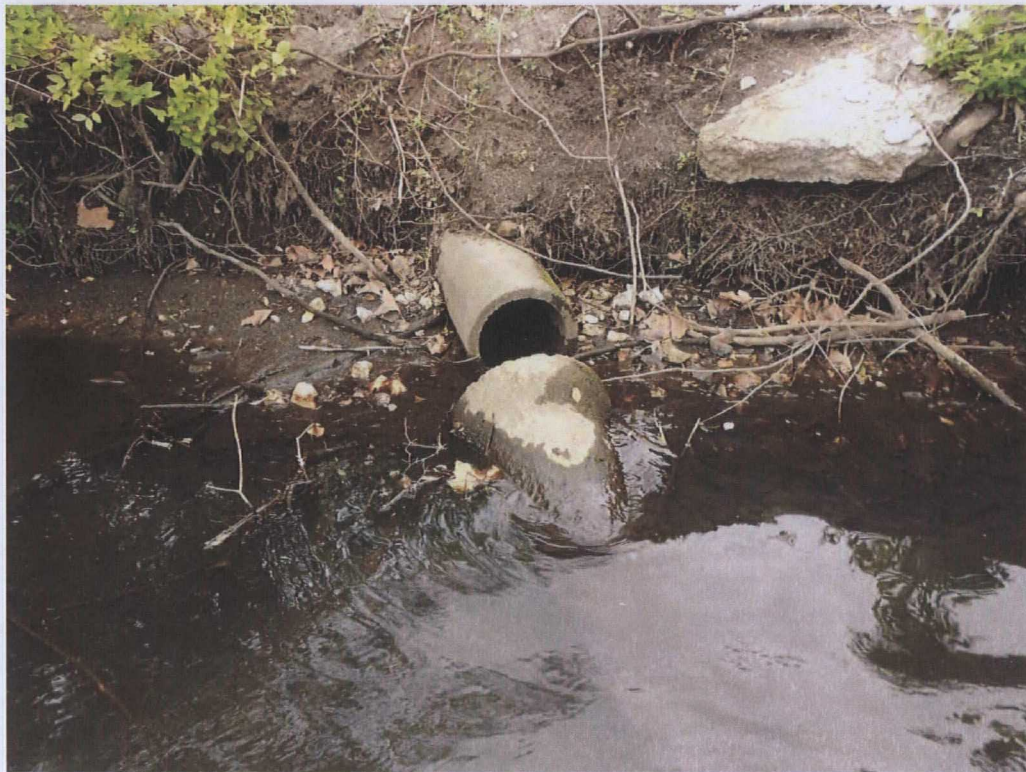
- The end section of pipe has failed from severe bank erosion and the second section is exposed ~18-24".

End section failed from severe bank erosion

- Remove the failed end section and install an isolation cofferdam with approximately 2' clearance. Because the outlet appears to be from previous development and not active, it may be possible to eliminate the isolation cofferdam and use caution to avoid undermining the structure.

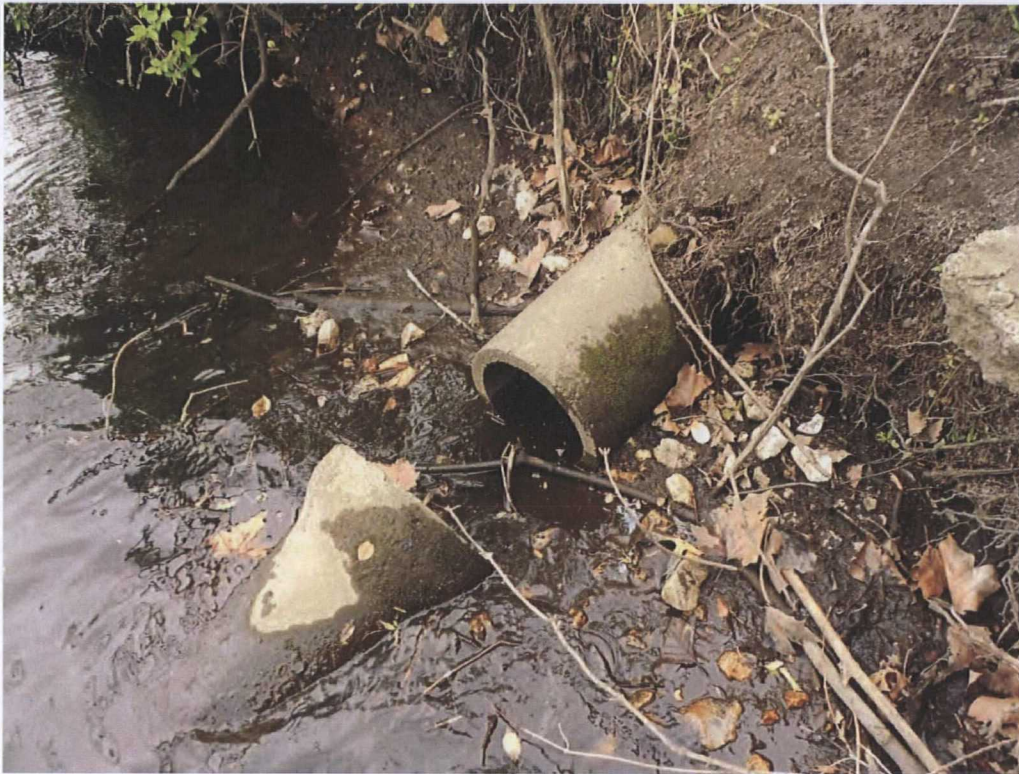
Separation between failed end section and current outlet

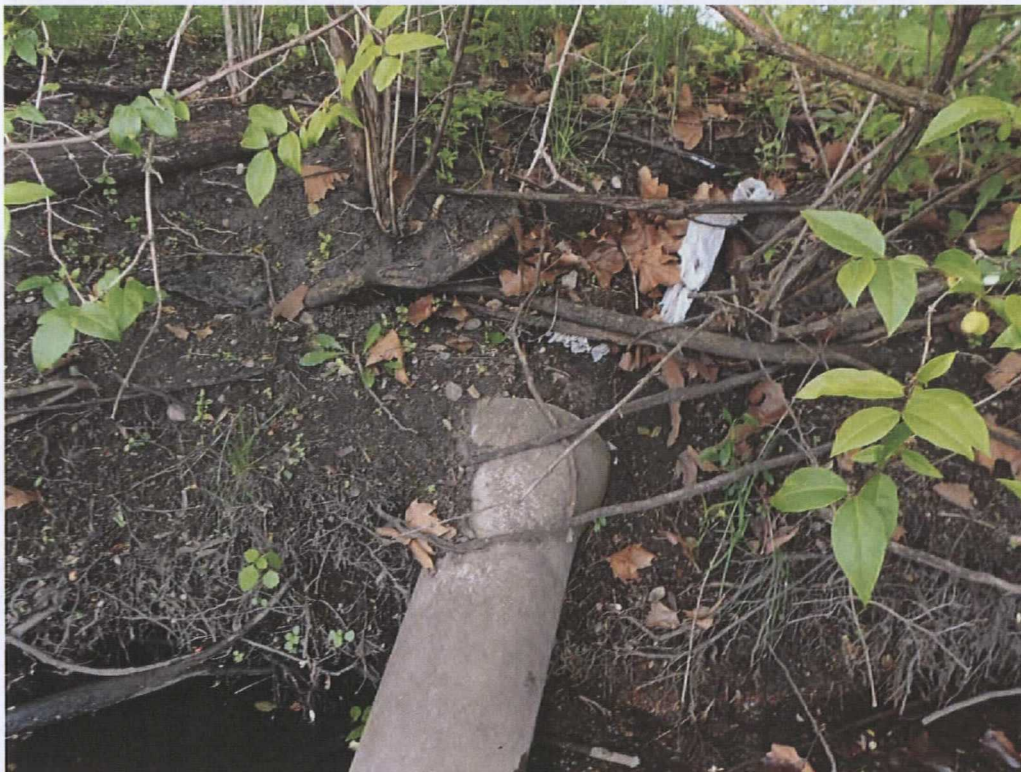
- The end section of pipe has failed from severe bank erosion.
- The outlet does not appear to be active.

End section failed from severe bank erosion

- Remove the failed end section. Because the outlet does not appear to be active, an isolation cofferdam is likely not required. The outlet is located far enough above the waterline in the bank that undermining is not a significant concern.

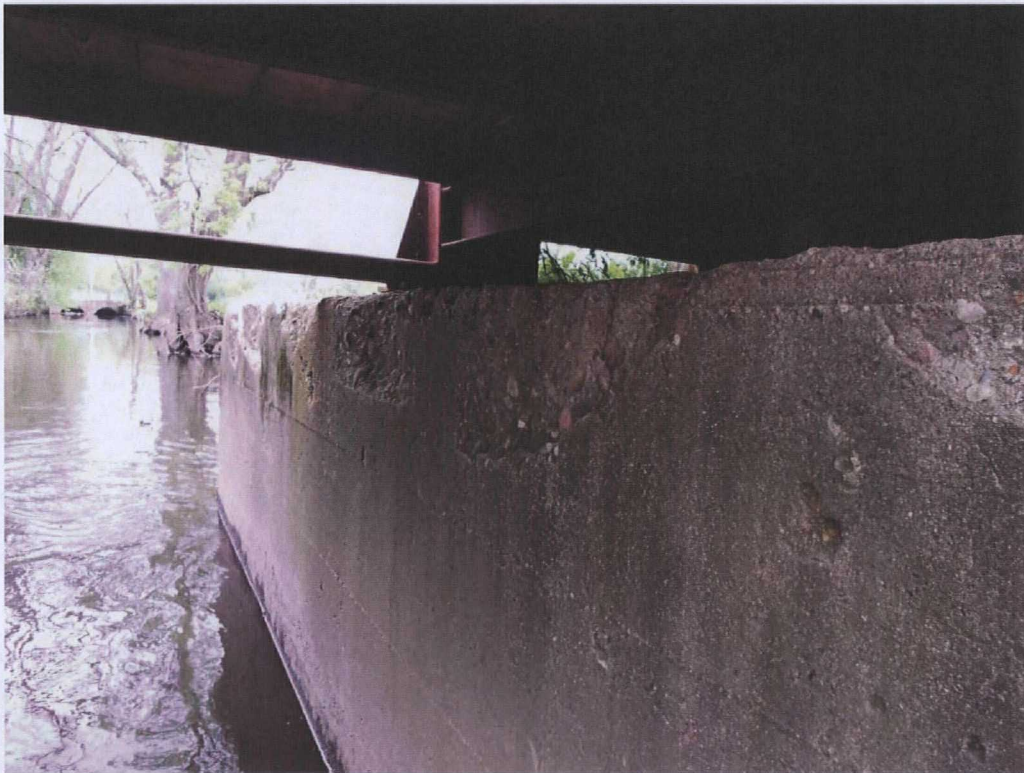
- Moderate bank erosion was noted around the southeast abutment. Roots from large stumps are holding the west banks.
- The top corners of the abutments are spalled throughout.
- The channel bottom is approximately 5' below the bottom chord of the truss. Logs and trash were noted in the northeast channel.
- The truss is weathering steel and has developed its patina, but minor pitting was noted.
- The timber decking has moderate weathering and splitting of planks throughout.

Spalling on the east abutment

- Construction records are not available for this structure, however it is suspected that the abutments are supported on spread footings several feet below the current channel bottom. We understand that the steel truss is to be temporarily removed to accommodate sediment removal. In this case, a cofferdam is recommended around each abutment to protect them from undermining. Because of the suspected depth of footing, it may be possible to begin sediment removal without cofferdams and install them only if the sediment removal is required below the bottom of footing elevation.
- If the truss is not removed, a simple isolation cofferdam across the channel is recommended upstream and downstream a minimum of 2' clear of the abutments.

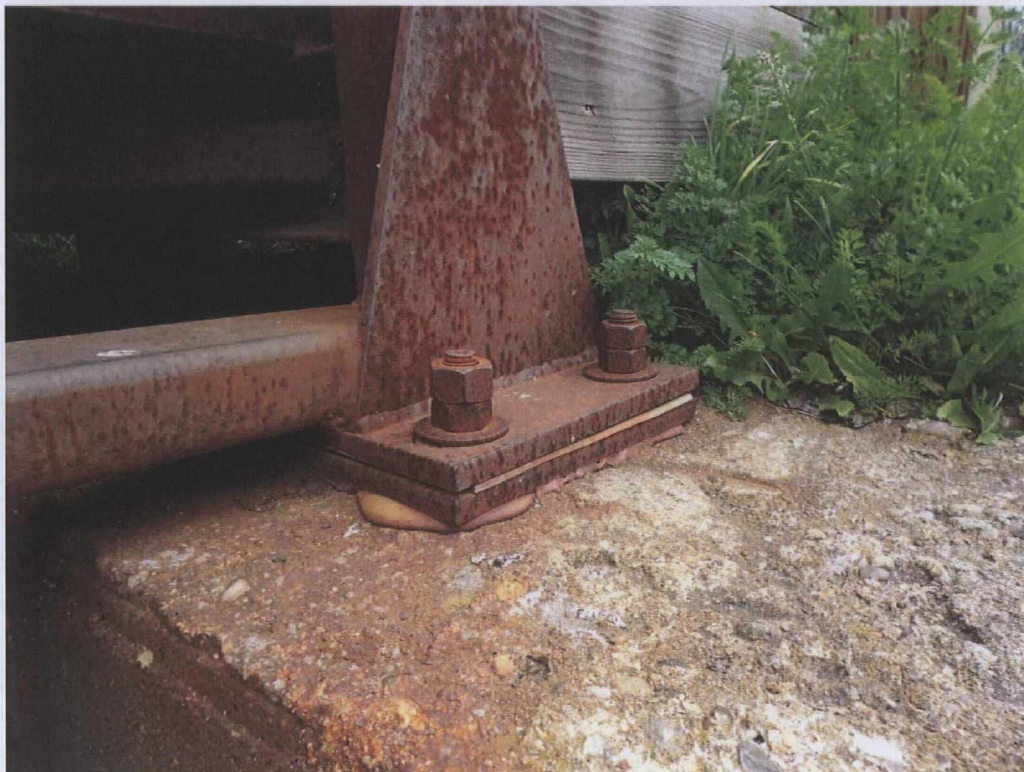
Minor pitting on steel at the southeast bearing

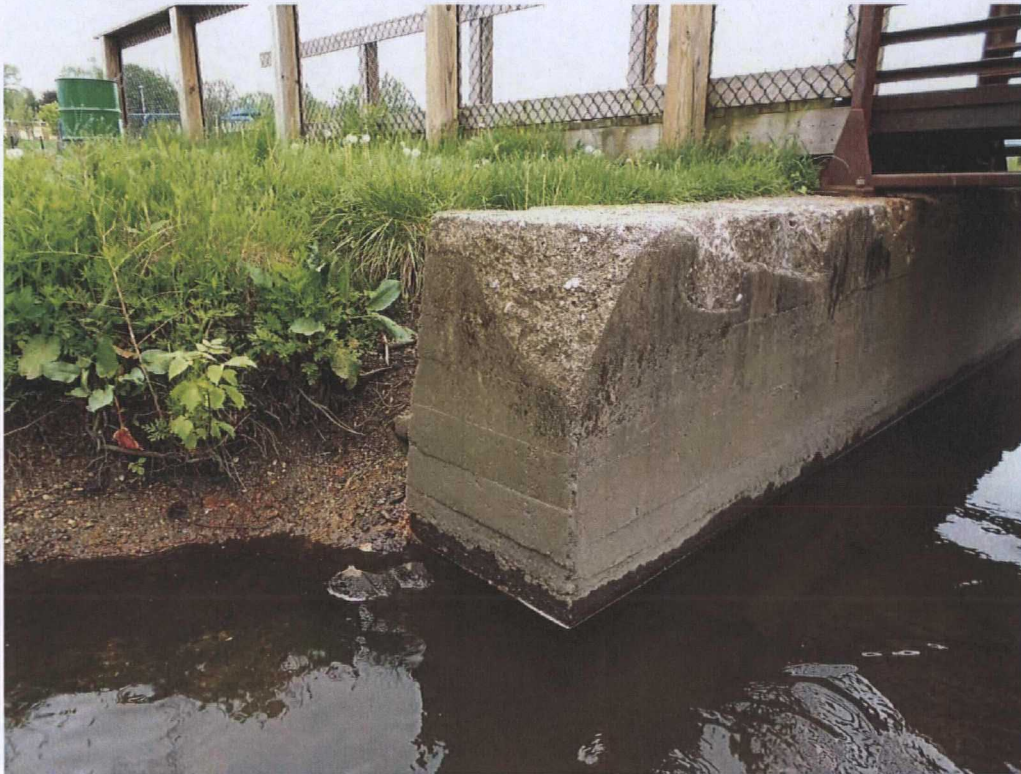
Abutment spalling in the northeast

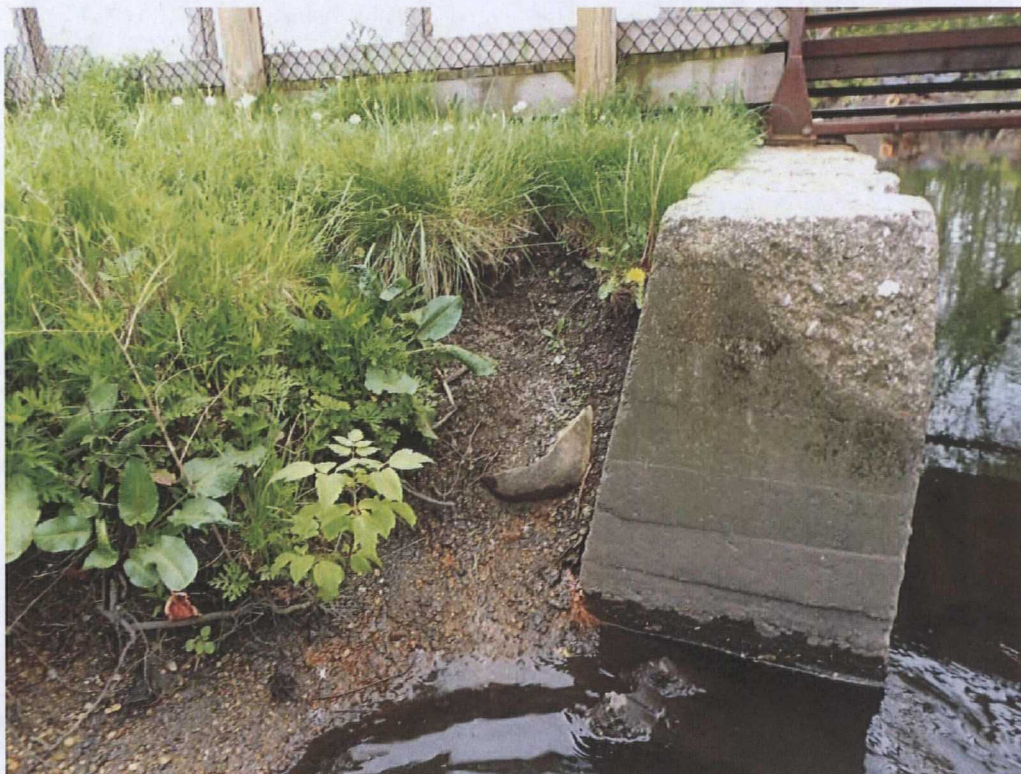
Bank erosion around northeast abutment
